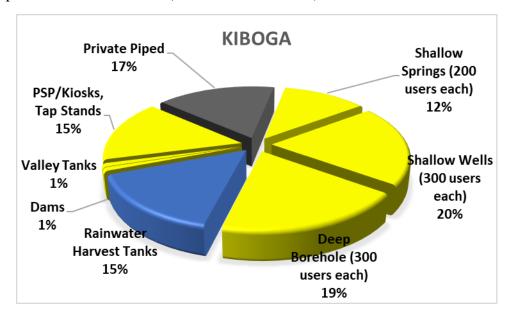
On average 35% of these water facilities were non-functional, including 50% of shallow wells with pumps and 41% of boreholes (Auditor General 2019).
